# Advanced Manufacturing Development of a Composite Empennage Component for L-1011 Aircraft

QUARTERLY TECHNICAL REPORT - NO. 13

This report is for the period 1 January 1979 through 31 March 1979

Lockheed Corporation  
Lockheed-California Company  
Post Office Box 551  
Burbank, California 91520

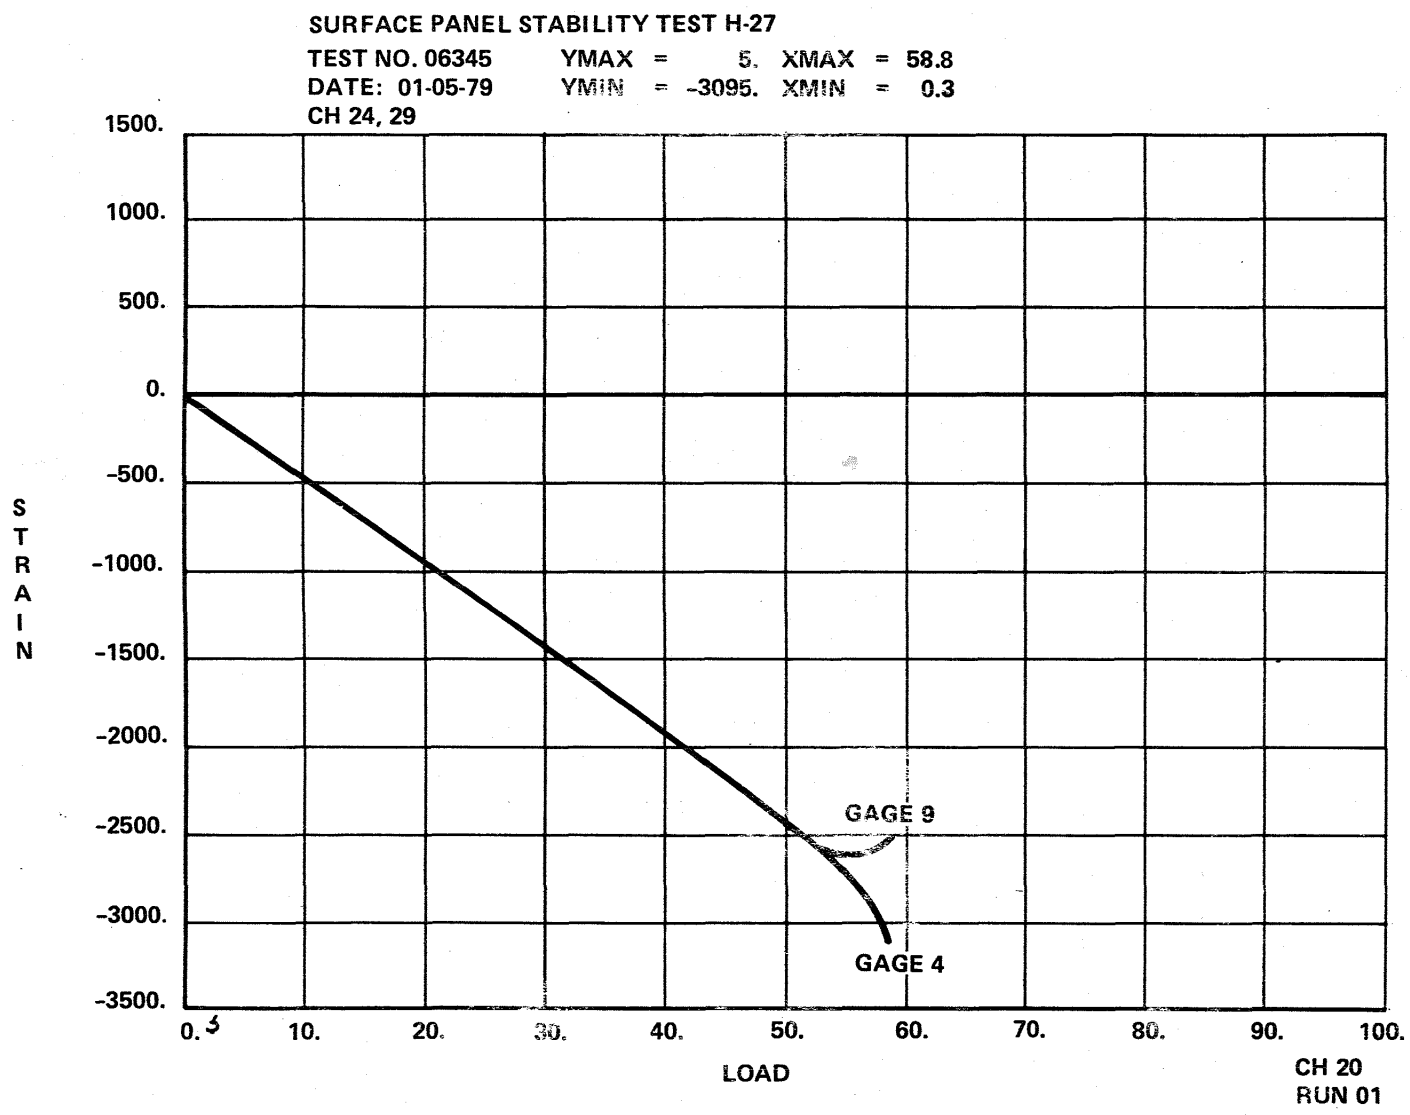
The test was conducted in two parts. First, the panel was loaded up to design ultimate compression load of 58,100 lbs with continuous data recordings. The panel load was reduced to 10,000 lbs and held while the recorded data was examined. The panel did show some initial buckling in the skin at 54,000 lbs load, as can be seen from Figure 4-5.

Figure 4-5. Strain Gages 4 and 9 - Limit Load Condition

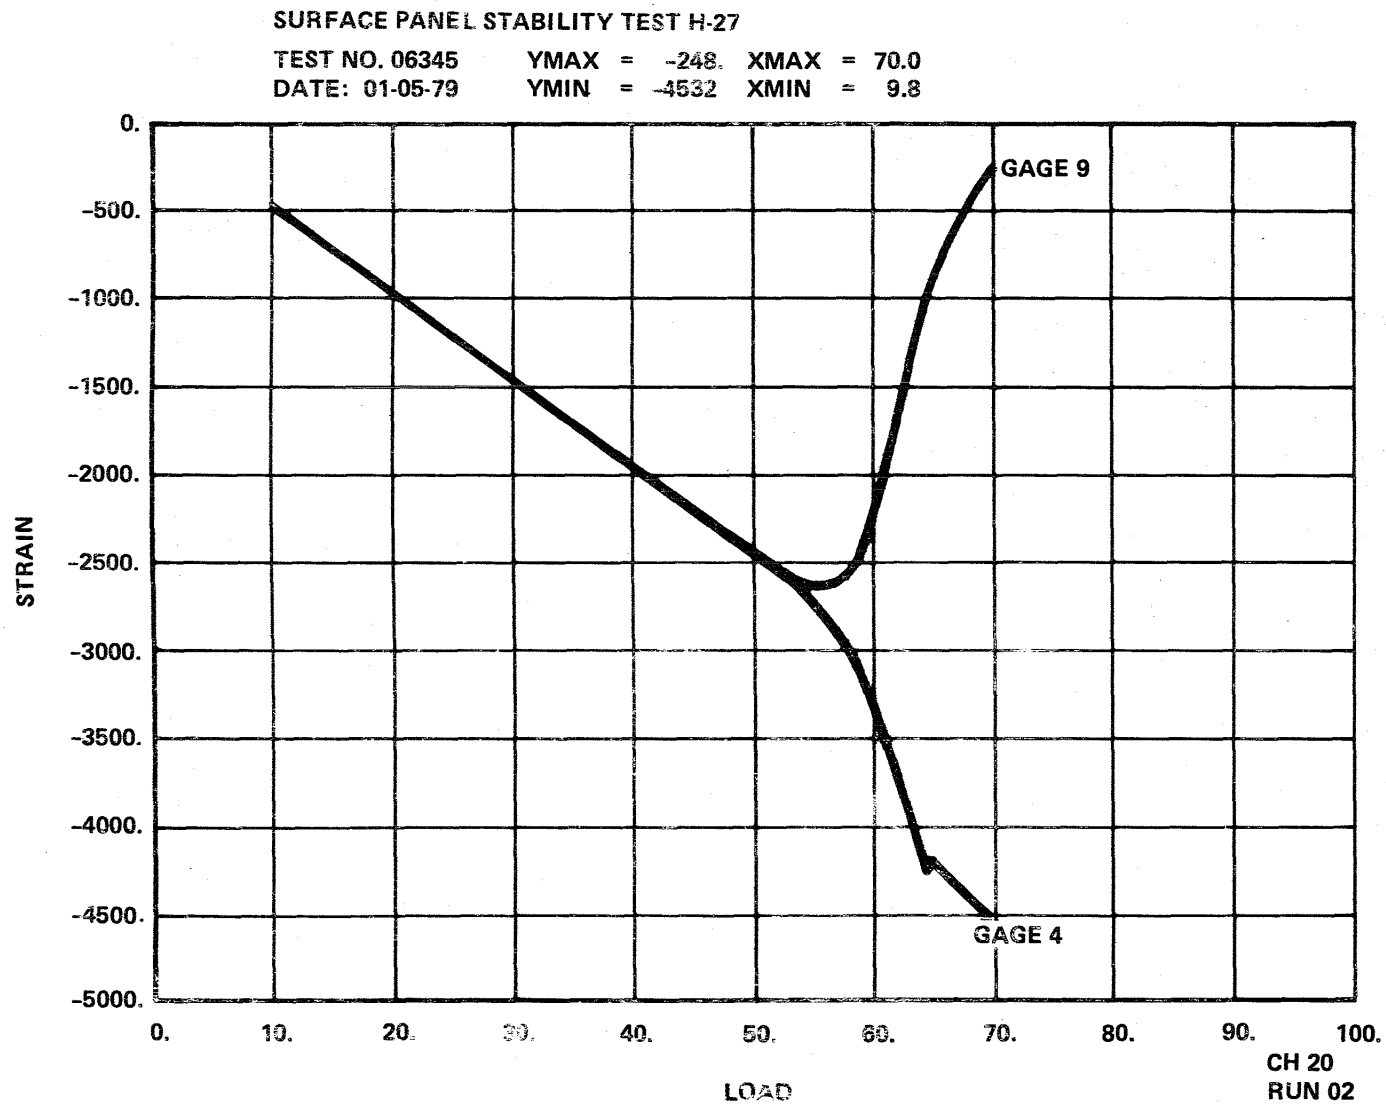
The second test objective was to run the panel continuously to failure with the data being continuously recorded during the test. Failure of the panel occurred at 70,000 lbs, 120% of ultimate load. Initial buckling was indicated in the back-to-back skin gages at about 54,000 lbs compression. Figures 4-6 and 4-7 show the buckling of the skin panels between the hats. The predicted failure loading was 80,000 lbs and predicted initial buckling was 48,000 lbs.

Figure 4-7. Strain Gages 4 and 9 - Failure Condition
